**Flood Control Project Maintenance  
Levee Inspections**  
**LMA District Cover Sheet**  
**Spring 2010 Levee Inspection Results**

**Reclamation District No. 0785 Driver**

**Levee Inspection Report By Mile - Spring 2010**

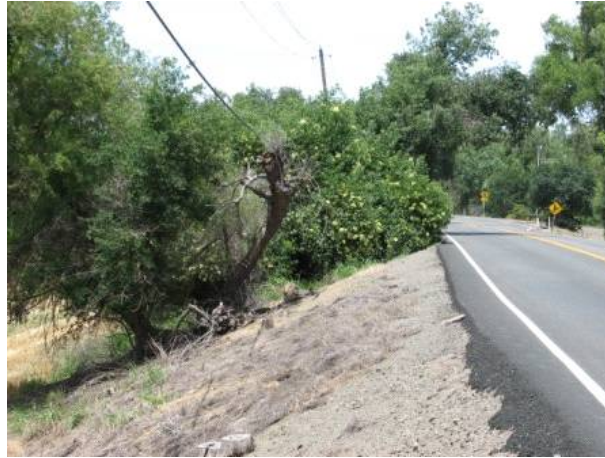
Levee Mile Report Line	1
Start Levee Mile	0.29
End Levee Mile	0.29
Location	Land Side
Category	Earthen Levee
Item	Vegetation

LMR No	Levee Mile		Category	Item	Location *	Rating **	Action/Comment	GPS Latitude/Longitude		Issue No. Photo
	Start	End						Start	End	
1	0.29	0.29	Earthen Levee	Vegetation	LS	W	Elderberries are blocking visibility and flood fight capability.	38.658467 ° -121.609573 °	38.658467 ° -121.609573 °	1 Y
2	0.41	0.45	Earthen Levee	Vegetation	LS	W	Elderberries are blocking visibility and flood fight capability.	38.657168 ° -121.608270 °	38.656697 ° -121.607845 °	2 Y
3	0.59	0.59	Earthen Levee	Encroachments	LS	PO	Buildings	38.655097 ° -121.606590 °	38.655097 ° -121.606590 °	3
4	0.85	0.94	Earthen Levee	Vegetation	LS	W	Elderberries are blocking visibility and flood fight capability.	38.651863 ° -121.604158 °	38.650777 ° -121.603182 °	5
5	1.32	1.32	Earthen Levee	Vegetation	LS	W	Elderberries are blocking visibility and flood fight capability.	38.646712 ° -121.599095 °	38.646712 ° -121.599095 °	6
6	1.65	1.65	Earthen Levee	Trim / Thin Trees	LS	M	Trim trees to at least five feet above ground level. Inspector Comments: this is the Haskin Ranch slope has some landscape and stairs on it	38.643310 ° -121.595138 °	38.643310 ° -121.595138 °	4

Elderberry

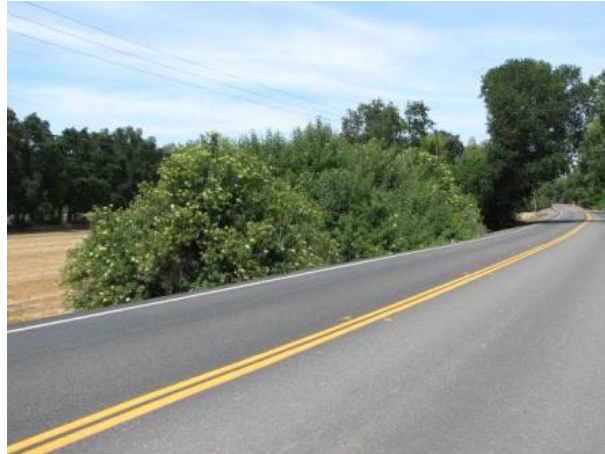
Levee Mile Report Line	2
Start Levee Mile	0.41
End Levee Mile	0.45
Location	Land Side
Category	Earthen Levee
Item	Vegetation

Elderberry

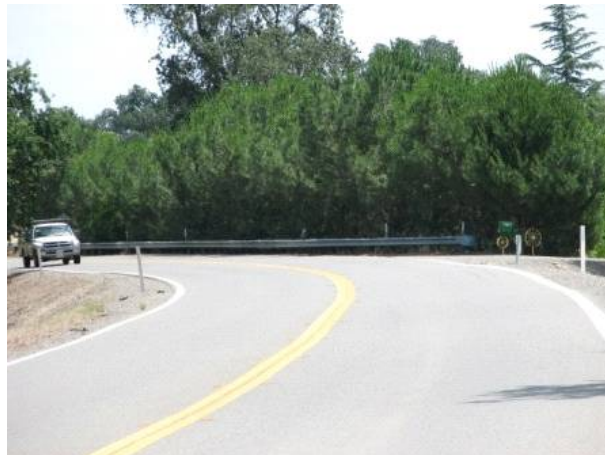
Levee Mile Report Line	7
Start Levee Mile	2.04
End Levee Mile	2.14
Location	Land Side
Category	Earthen Levee
Item	Encroachments

7	2.04	2.14	Earthen Levee	Encroachments	LS	PO	Landscaping Inspector Comments: pine trees need to be raised for 5' clearance	38.641623 ° -121.588558 °	38.642005 ° -121.586993 °	8 Y

pines and oleanders along shoulder

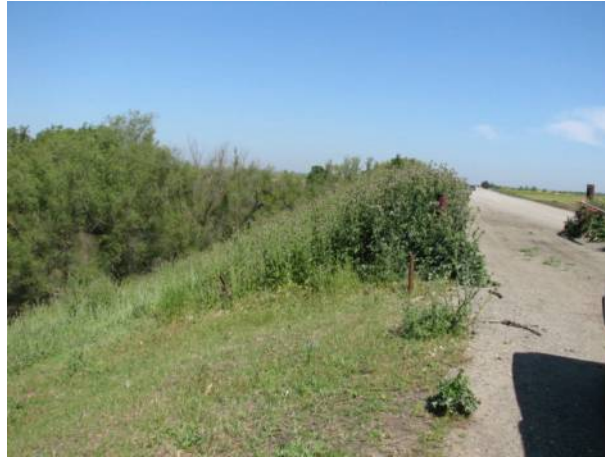
Levee Mile Report Line	2
Start Levee Mile	0.61
End Levee Mile	0.61
Location	Water Side
Category	Earthen Levee
Item	Vegetation

thistle at gate waterside

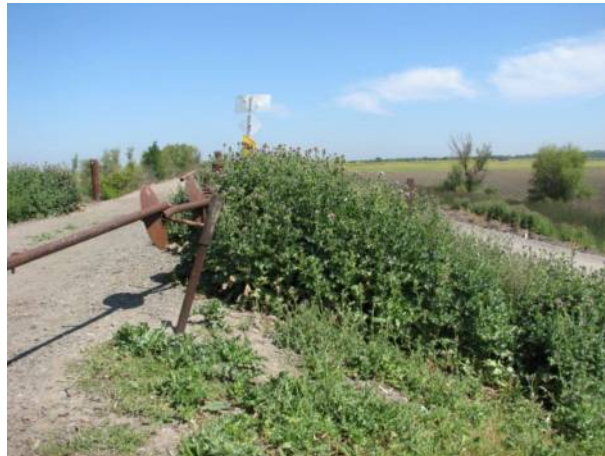
Levee Mile Report Line	3
Start Levee Mile	0.61
End Levee Mile	0.61
Location	Land Side
Category	Earthen Levee
Item	Vegetation

thistle at gate
